Vehicle: All Technical Service Bulletins

Bulletin No.: 67-61-14B

Date: September, 1997

Engine Noise (Install Valve Stem Oil Seal)

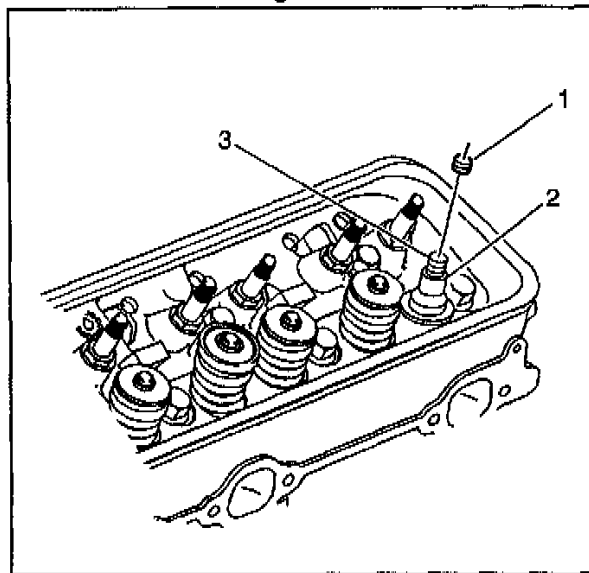
Figure 1

The noise may be caused by a low level of lubrication on the exhaust valve stem, creating a "slip-stick" condition between the valve stem and valve guide.

Install the valve stem oil seal listed below, ON THE EXHAUST VALVE GUIDES ONLY.

Lightly lubricate the seal, and with finger pressure only, push it on to the valve stem and down on to the exhaust valve guide. (See Figure 1)

DO NOT install this seal on intake valve guides. This seal is NOT released for intake valve application in the above identified vehicles.
