**Vehicle: All Technical Service Bulletins**  
**Mud Build-Up Inside Front Door - New Seal**

Group Ref.: Body  
Bulletin No.: 431006  
Date: February, 1994

**SUBJECT:**  
DIRT BUILD-UP ON ROCKER AND LOWER INBOARD DOOR SURFACE (INSTALL FOAM SEAL)

**MODELS:**  
1992-94 BUICK ROADMASTER  
1992-94 CADILLAC FLEETWOOD  
1991-94 CHEVROLET CAPRICE  
1991-92 OLDSMOBILE CUSTOM CRUISER

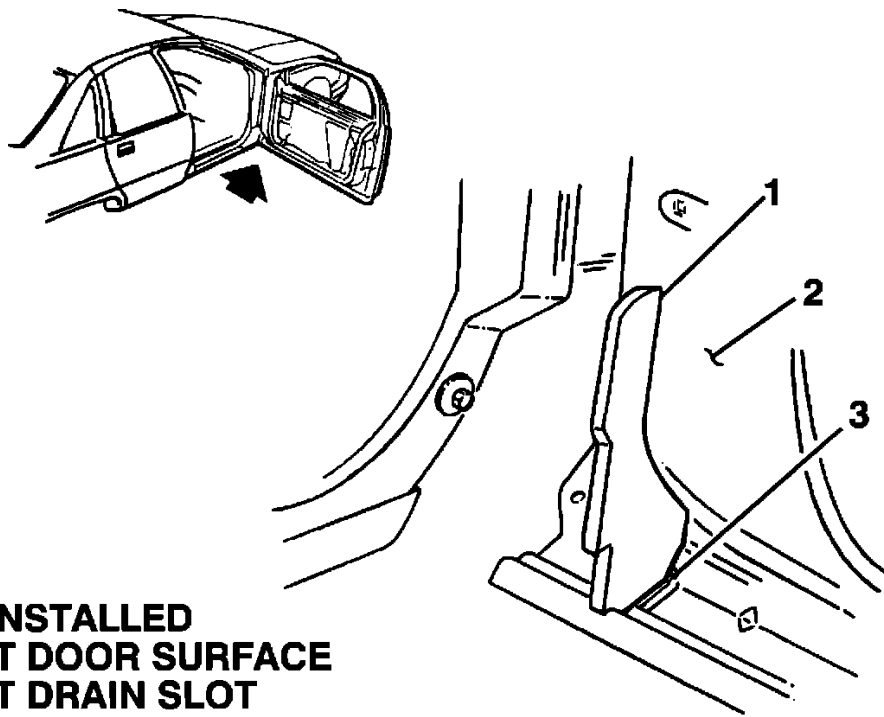
**Figure 1**

Some owners may express dissatisfaction with mud collected along inside bottom of front door and rocker.

Install new foam seal, P/N 10249066, (when ordering two (2) pieces are required), one for left hand front door and one for right hand front door. Follow procedures listed below for installation:

5. Align the foam seal vertically to the front lower door surface and install it just forward of the front drain hole. (See illustration.) After installation, press seal firmly to fully seat the seal to the door.

In some cases it may be necessary to adjust the door inboard so that the lower auxiliary contacts the rocker.
