3-2 Part Throttle Downshift Flare

Bulletin No.: 67-71-47

Subject:
3-2 Part Throttle Downshift Flare (Replace 3-2 Solenoid)

Models:
1996 Buick Roadmaster
1996 Cadillac Fleetwood
1996 Chevrolet Camaro, Caprice, Corvette
1996 Pontiac Firebird
1996 Chevrolet and GMC C/K, M/L, S/T, G Models
1996 Oldsmobile Bravada
with HYDRA-MATIC 4L60-E (RPO M30)

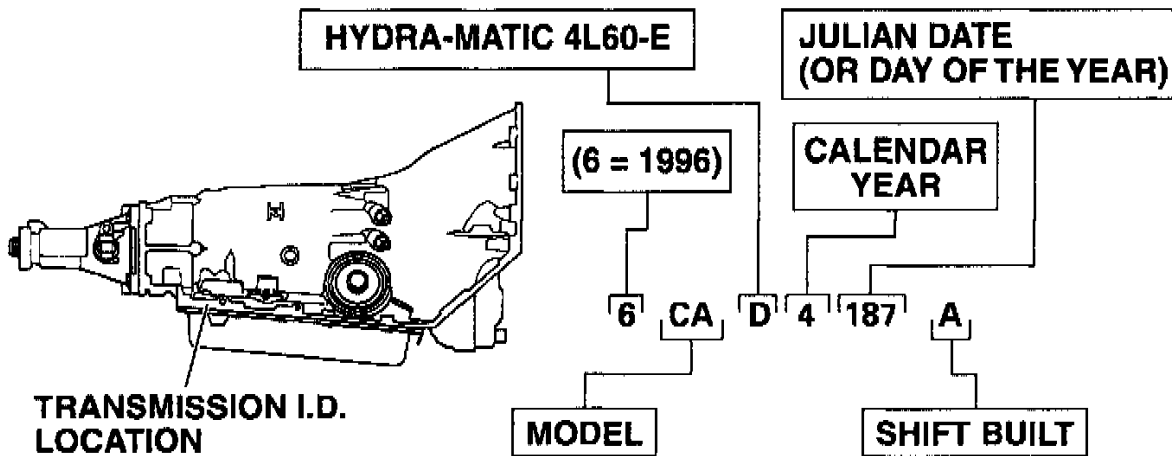
Figure 1 - Hydra-Matic 4L60-E Transmission Identification Information

Condition (Figures 1 and 2)

Some owners of the above models with a HYDRA-MATIC 4L60-E transmission (built before May 24, 1996/Julian Date 6145) may experience an engine speed flare of 1000-2000 RPM, during a part throttle downshift at 19-31 mph. This condition will not set any DTC's (Diagnostic Trouble Codes).

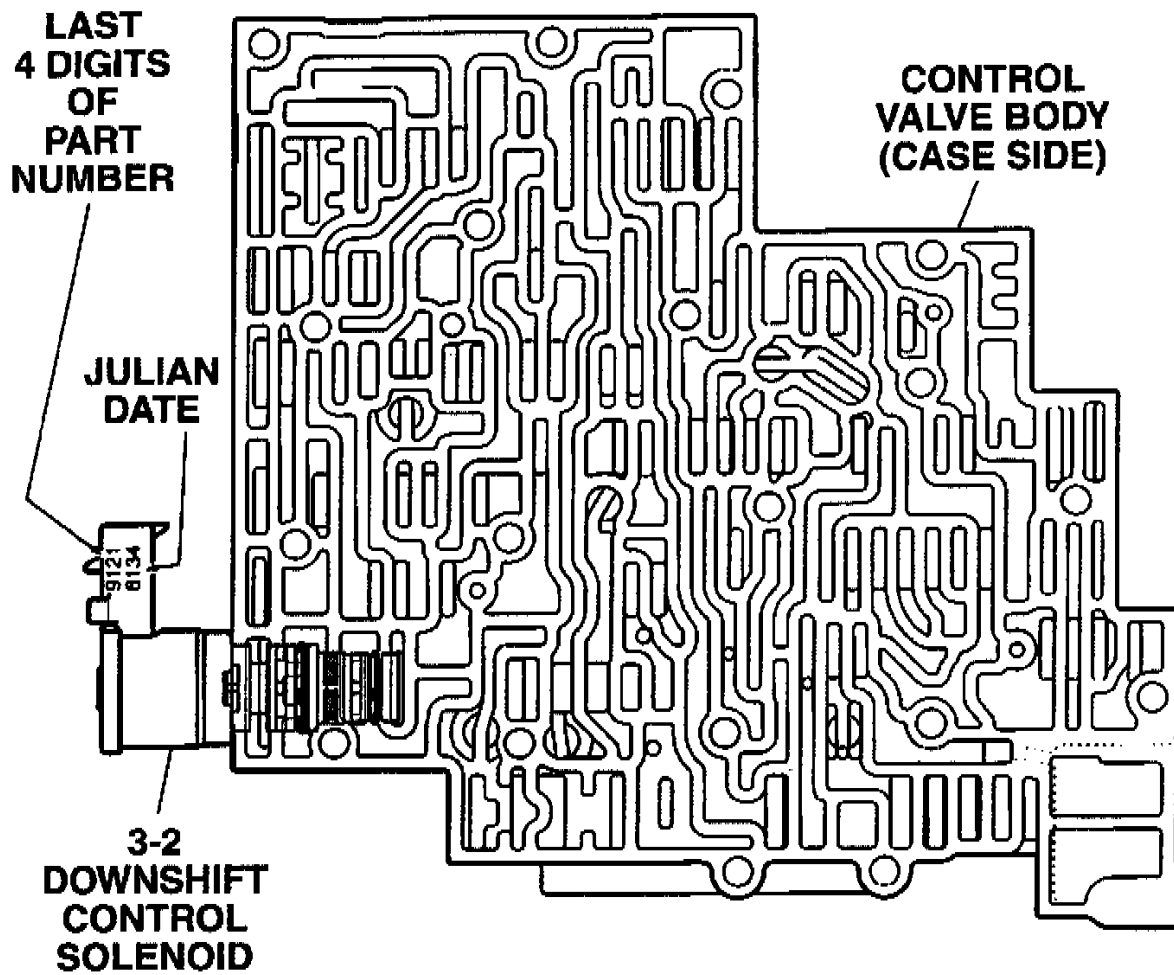
Figure 3 - Location and Identification of the 3-2 Control Solenoid on the Control Valve Body

Exhaust seat on the 3-2 control solenoid backing out.

Correction (Figure 3)

Replace the 3-2 control solenoid. Julian Date on the solenoid will be May 13, 1996 (6134) or later.
