1994 Chevrolet Caprice V8-350 5.7L

# Vehicle: All Technical Service Bulletins Rear Wheel/Tire Position in Wheel Well Opening

BULLETIN NO.: 53-34-03

Rear Wheel/Tire Position in Wheel Well Opening (Elongate Axle Bracket Control Arm Attaching Bolt Holes)

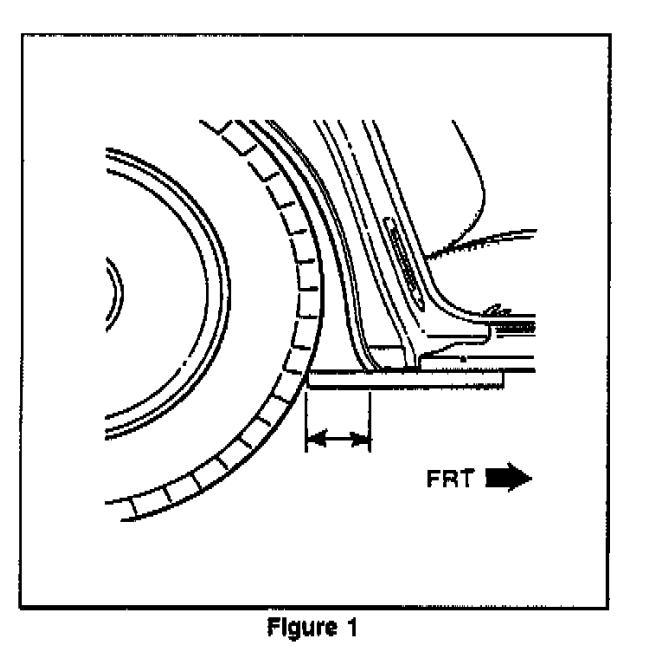
- 2. Using lower edge of sill plate as a guide for scale/ruler, measure distance from tire to wheel well opening on both sides of vehicle (Reference Figure 1).
- 3. Subtract smaller dimension from larger one and refer to chart below to determine amount holes of axle lower control arm bracket are to be elongated.
