Powertrain Management: All Technical Service Bulletins Stalls/Runs Out of Fuel While Gauge Shows Fuel Remaining

Bulletin No.: 67-65-19

Subject:
Vehicle Stall or Runs Out of Fuel While Gauge Shows Fuel Remaining (Repair/Replace Fresh Air Hose/Canister and Bracket)

Models:
1994-95 Buick Roadmaster
1994-95 Cadillac Fleetwood
1994-95 Chevrolet Caprice, Impala SS
with 4.3L, 5.7L Engines (VINs W, P - RPOs L99, LT1)

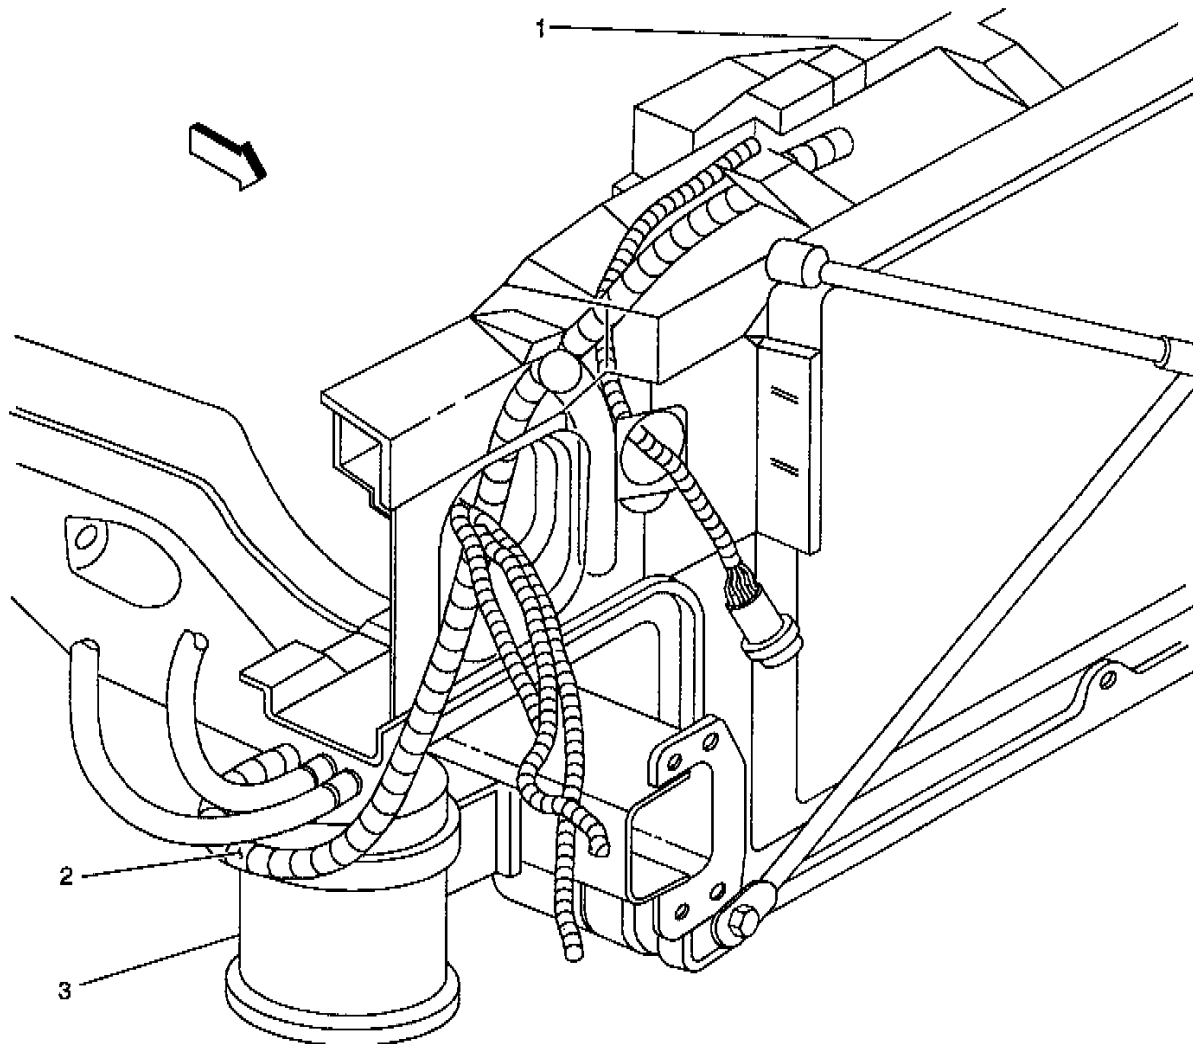
Figure 1

- 1. Radiator Support
- 2. Fresh Air Hose
- 3. Fuel Vapor Canister

- 5. If the fresh air hose is located in the RH fender well, relocate it to the front radiator support area. See Figure 1.
- 6. If the fresh air hose is not kinked or damaged and there is still a restriction, replace the canister and bracket.
